**DYNAMIC SCIENCE, INC.**  
**In-Depth Accident Investigation**

**Contract Number DTNH22-94-D-27058**  
**Case Number DSI-94-AB-15**

## TECHNICAL SUMMARY

[REDACTED]  
This single vehicle crash occurred on a four-lane, divided, asphalt paved, rural road in [REDACTED] Maryland during the early morning hours of a summer weekday ([REDACTED] 94).

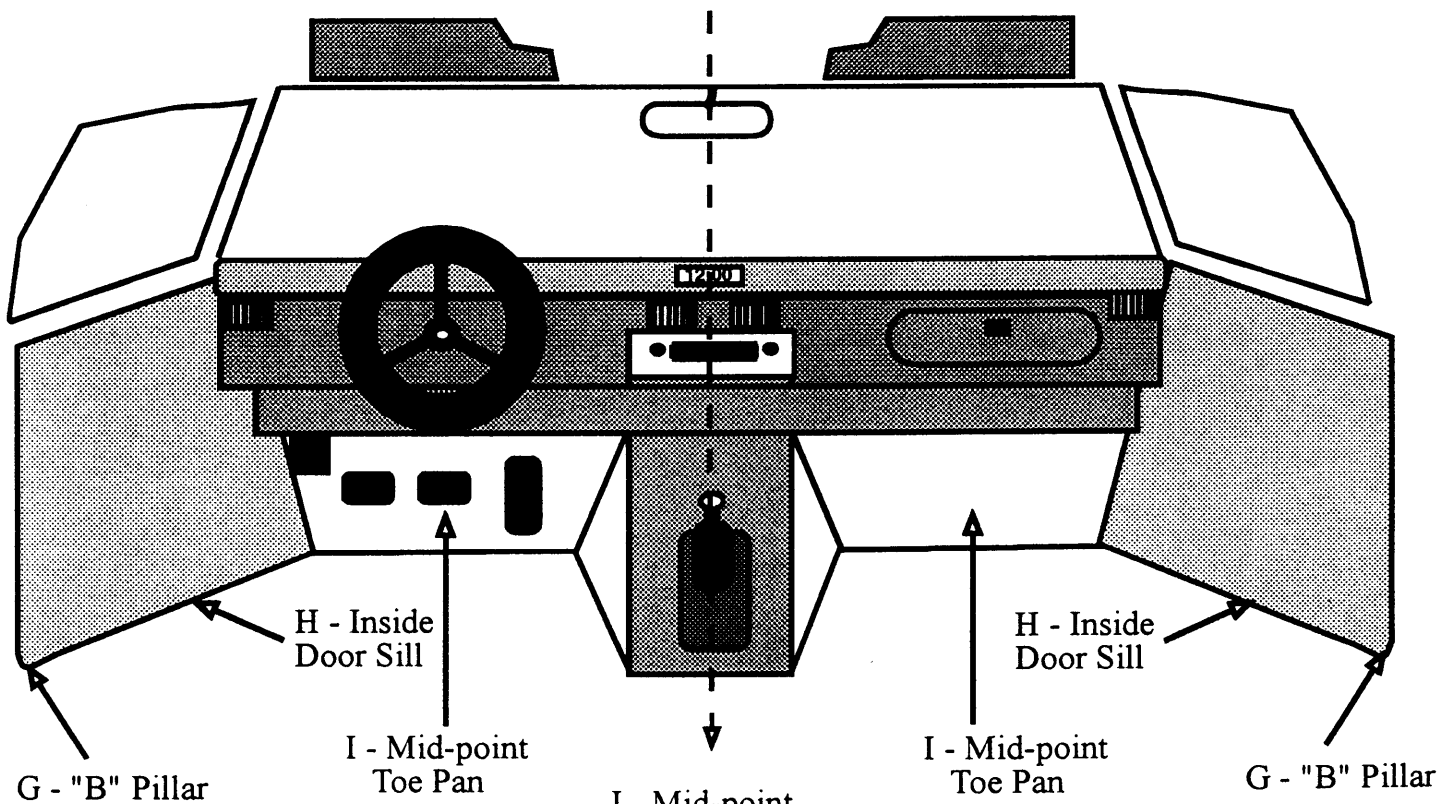
Left Side				EXEMPLAR MEASURES	Right Side				
A-B	<u>51.0</u>	cm	<u>20.1</u>	in <u>51cm/20.1in</u>	A-B	<u>47.6</u>	cm	<u>18.7</u>	in
B-C	<u>-14.0</u>	cm	<u>-3.9</u>	in <u>30cm/12.0in</u>	B-C	<u>26.0</u>	cm	<u>10.2</u>	in
B-D	<u>38.0</u>	cm	<u>15.0</u>	in <u>56cm/22.0in</u>	B-D	<u>60.0</u>	cm	<u>23.6</u>	in
A-B-C	<u>79.0</u>	cm	<u>31.1</u>	in <u>107cm/42.0in</u>	A-B-C	<u>107.6</u>	cm	<u>42.4</u>	in
C-E	<u>70.0</u>	cm	<u>27.6</u>	in <u>57cm/22.5in</u>	C-E	<u>46.0</u>	cm	<u>18.1</u>	in
B-E	<u>27.0</u>	cm	<u>10.6</u>	in <u>28cm/11.0in</u>	B-E	<u>22.0</u>	cm	<u>8.7</u>	in

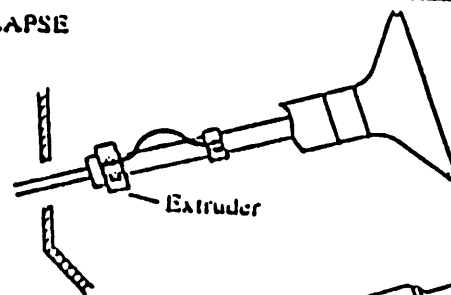
Direction and Magnitude of Steering Column Movement

COMPLETE  
COLLAPSE  
UNABLE TO MEASURE  
DUE TO INTERIOR DAMAGE

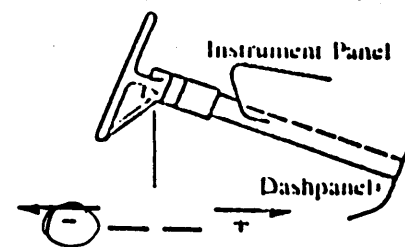
### Longitudinal Movement

COMPARISON VALUE	—	DAMAGED VALUE	=	MOVEMENT
VERTICAL	ESTIMATED	—	15cm (6in)	=	+15cm (+6in)
LATERAL	ESTIMATED	—	24cm (8in)	=	+24cm (+8in)
LONGITUDINAL	ESTIMATED	—	25cm (10in)	=	-25cm (10in)

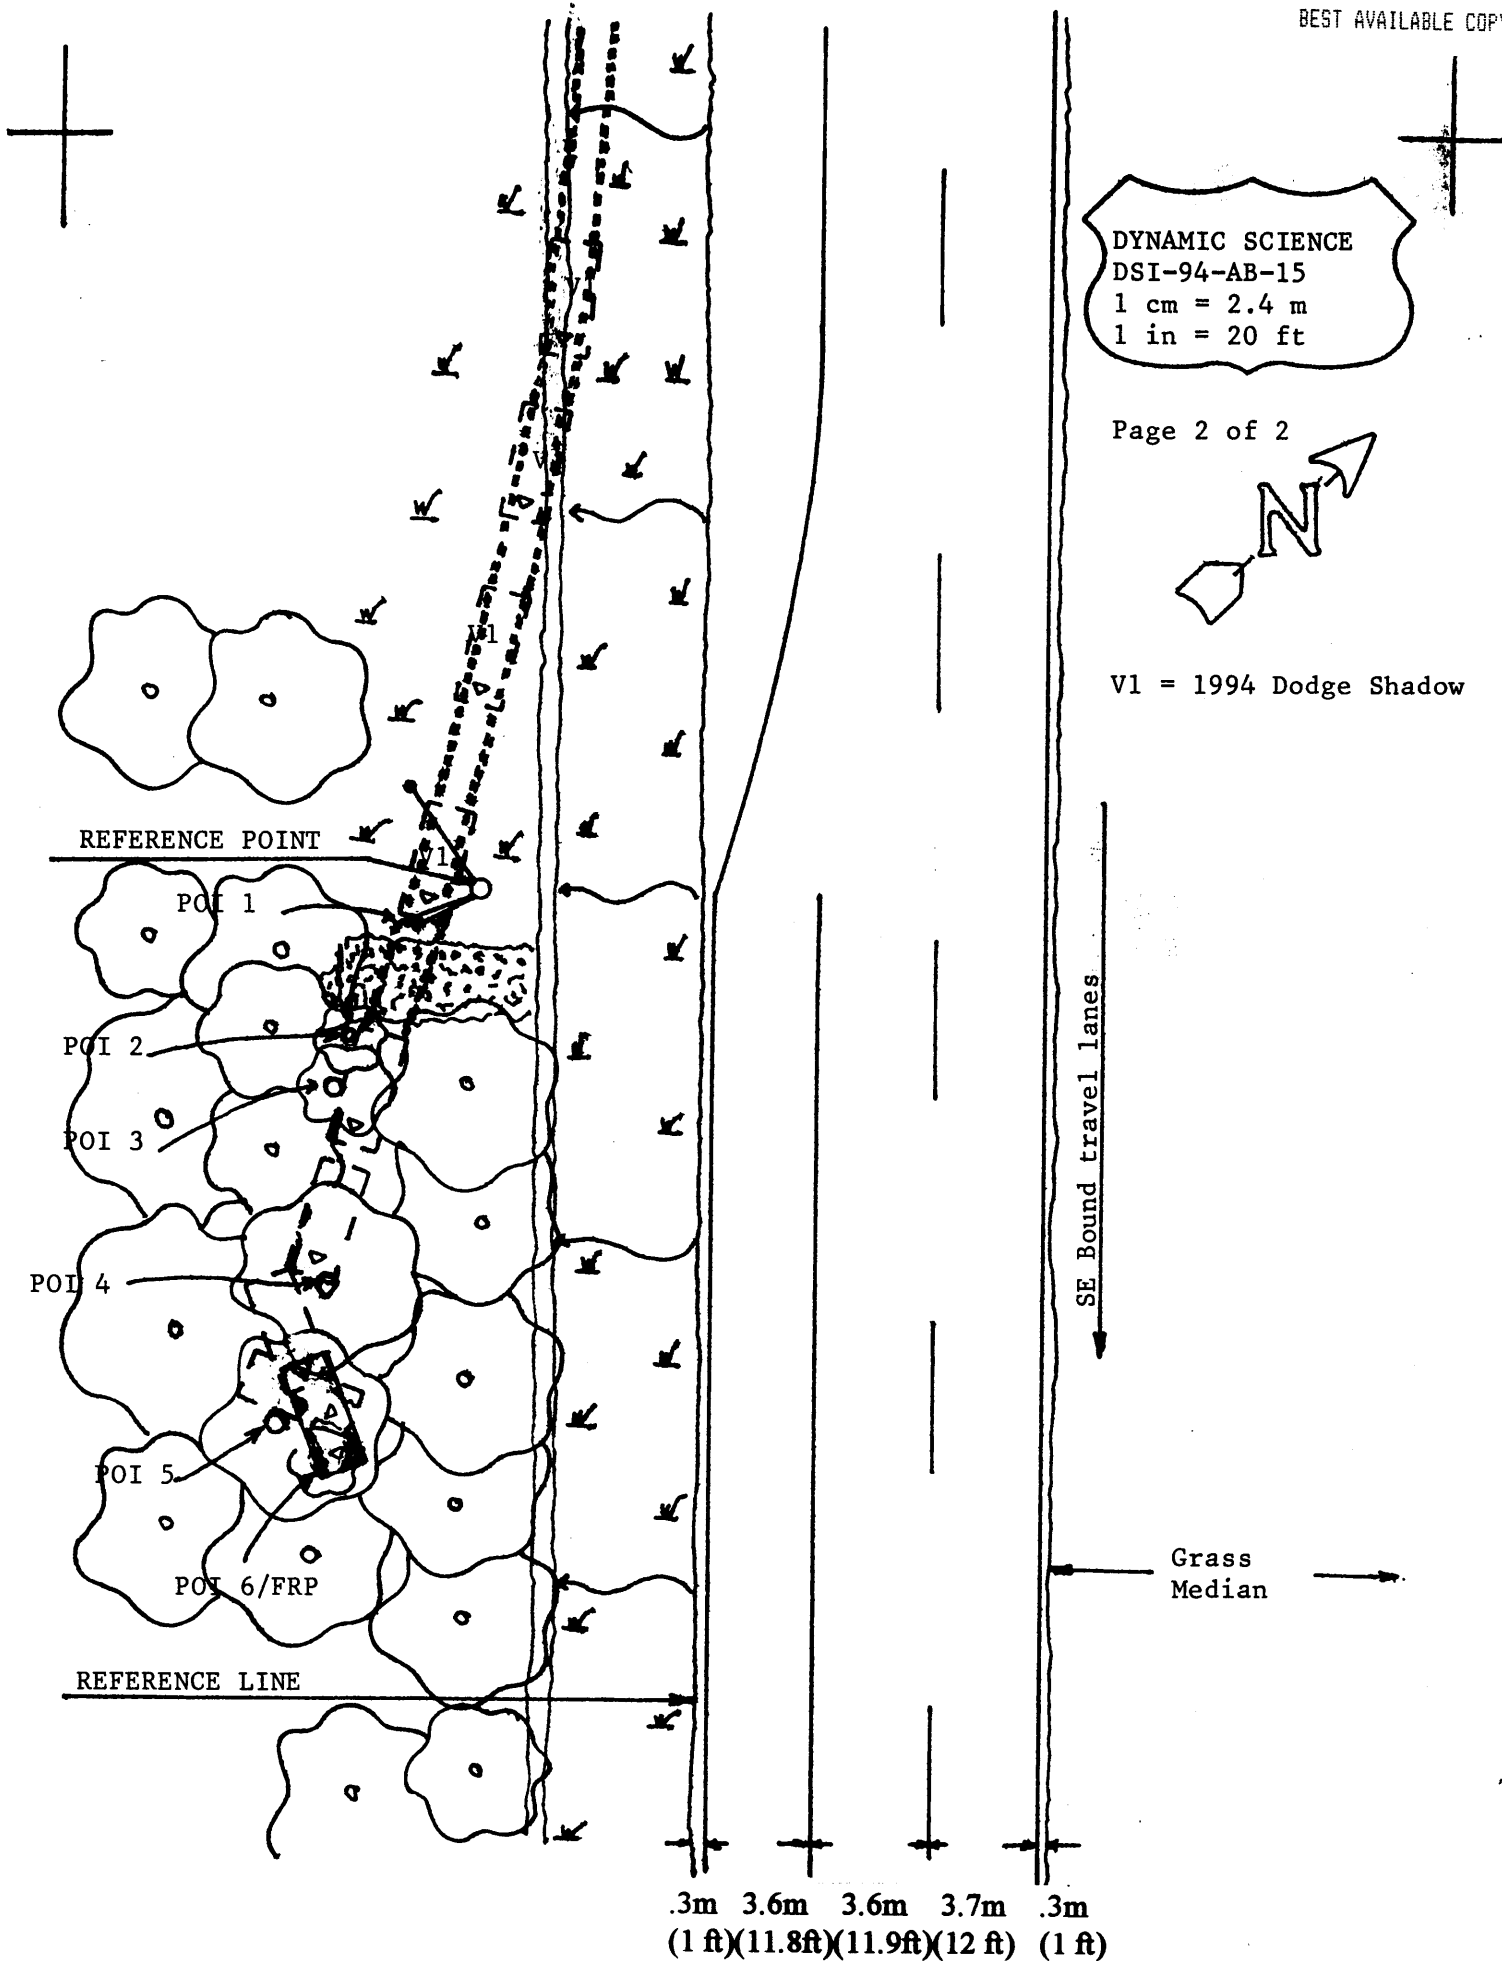
## COLLISION MEASUREMENTS

Southeast bound travel lanes

Grass  
Median

DATA POINT	LONGITUDINALS	LATERALS
SW edge of SE bound road	30.5 m (100 ft) NW	0
White line separates shoulder and SE bound travel lane 1	30.5 m (100 ft) NW	3.9 m (12.8 ft) NE
Broken white line separates SE bound travel lanes 1 and 2	30.5 m (100 ft) NW	7.5 m (24.7 ft) NE
Yellow line, NE edge of SE bound travel lane 2	30.5 m (100 ft) NW	11.2 m (36.7 ft) NE
SW edge of grass median	30.5 m (100 ft) NW	11.5 m (37.7 ft) NE
NE edge of grass median	30.5 m (100 ft) NW	16.1 m (52.9 ft) NE
NE edge of NW bound road	30.5 m (100 ft) NW	27.1 m (88.9 ft) NE
R/F wheel leaves road	73.2 m (240.2 ft) NW	0
L/F wheel leaves road	53.5 m (175.4 ft) NW	0
R/F wheel crosses drainage ditch	17.4 m (57.1 ft) NW	5.3 m (17.4 ft) SW
L/F wheel crosses drainage ditch	12.1 m (39.8 ft) NW	5.3 m (17.4 ft) SW
POI 1 - guy wires/front bumper	.9 m (3.1 ft) SE	8.9 m (29.3 ft) SW
POI 2 - small tree/R/F fender	4.5 m (14.7 ft) SE	10.8 m (35.3 ft) SW

As Vehicle 1 neared the stand of trees, and without any apparent evasive actions, the front bumper sheared a pair of utility pole guy wires. A CDC of 12FZLN1 was assigned using a PDOF of 360 degrees. The combined direct and induced damage width was approximately 30.5 cm (12 in), and the maximum crush depth was less than 3.8 cm (1.5 in).

Vehicle 1 continued south, in a straight line without evasive action, for approximately 3.5 m (11.5 ft) where the right front fender impacted a 5.1 cm (2 in) diameter tree in a sideswipe configuration. A CDC of 12RFES2 was assigned using a PDOF of 360 degrees. The combined direct and induced damage length was approximately 140 cm (55.1 in), and the maximum crush depth was 25 cm (9.8 in).

Continuing south for approximately 1.8 m (6 ft), the right front door impacted a 21.1 cm (8.3 in) diameter tree in a sideswipe configuration. The CDC for this impact was 12RPES1 using a PDOF of 360 degrees. The combined direct and induced damage length was approximately 68 cm (26.8 in), and the maximum crush depth was 11 cm (4.3 in). Delta V's for events 1, 2 and 3 were not computed due to impact configurations and/or subsequent impacts.

Vehicle 1 continued south, in a straight line, 6.4 m (21 ft) from event 3 and the left front plane impacted a 64.3 cm (25.3 in) diameter tree in a head-on configuration. The Delta V for this impact was computed, using CRASH III PC, as 37 KPH (23 MPH) using a CDC of 12FYEW5 and a PDOF of 355 degrees. The combined direct and induced damage width was 152 cm (60 in), and the maximum crush depth was 126.6 cm (49.9 in) at C<sub>1</sub>. The forces in this event (event 4) exceeded the manufacturer's threshold in the supplemental restraint system, and the driver's side airbag deployed.

Vehicle 1 continued south for 4.6 m (15 ft) while rotating counter-clockwise approximately 70 degrees and impacted a 53.8 cm (21.2 in) diameter tree with the right side plane. The CDC for this impact was 03RPAW3 using a PDOF of 80 degrees. The combined direct and induced damage width was approximately 80 cm (31.5 in), and the maximum crush depth was 28.5 cm (11.2 in) approximately 175.2 cm (69 in) rearward of the right front axle.

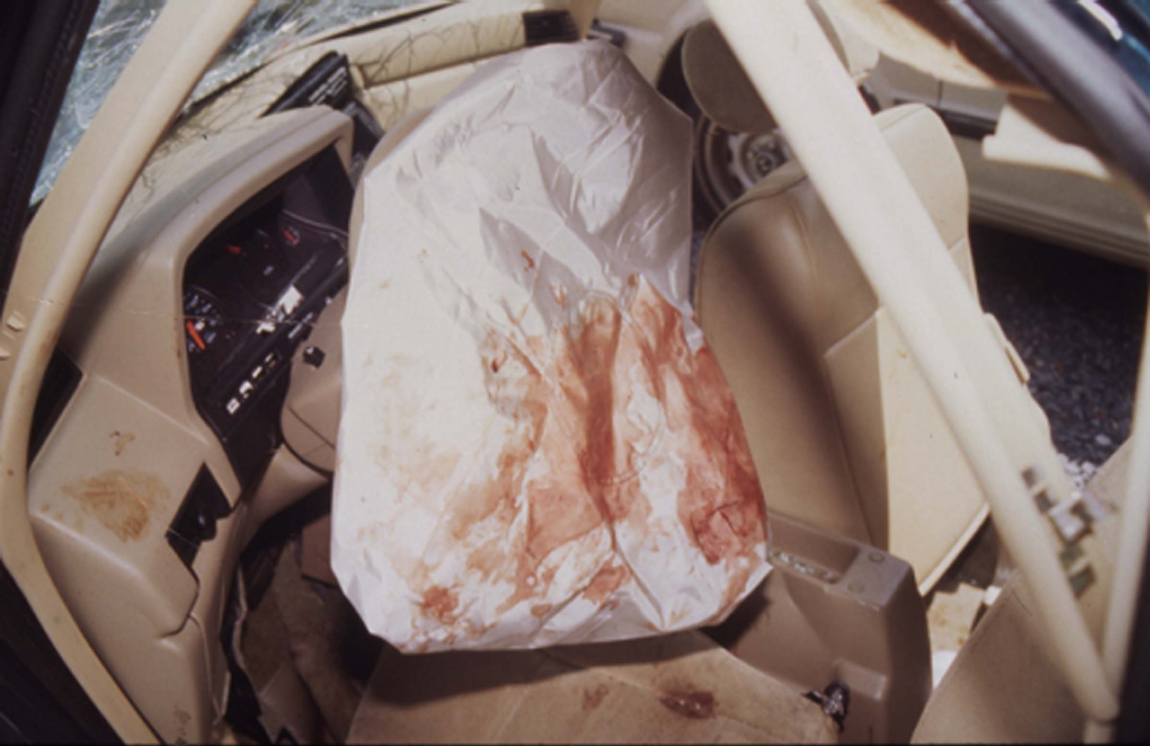
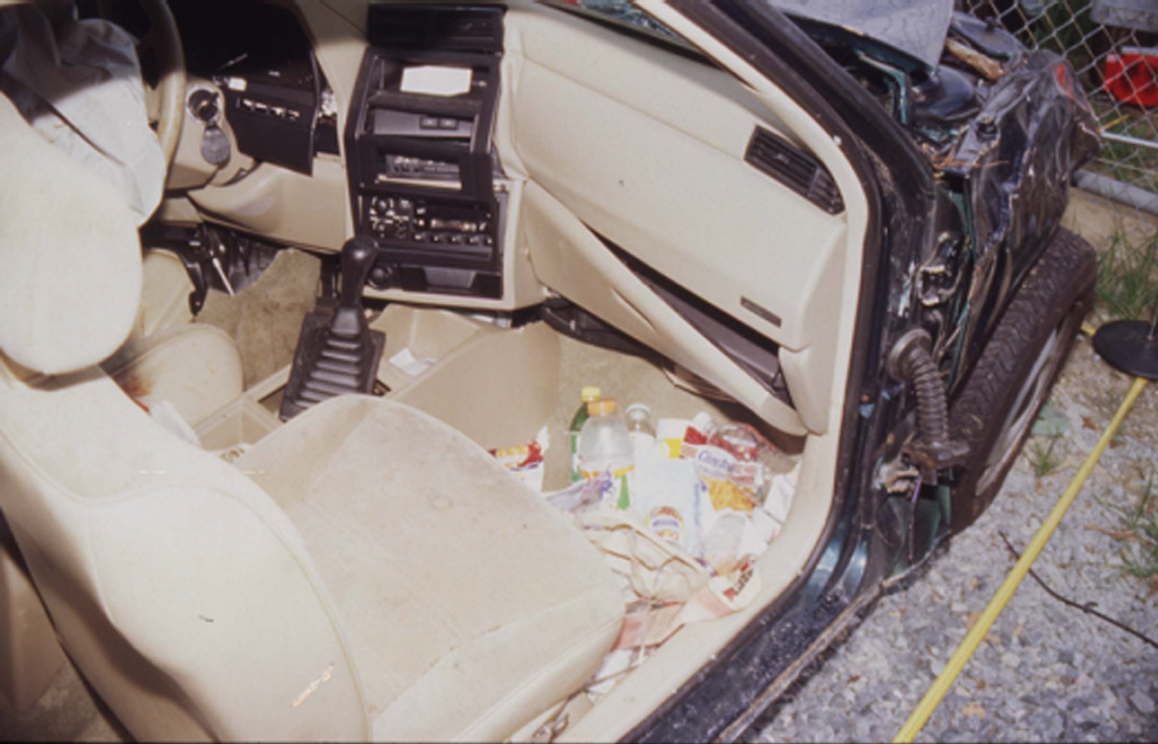
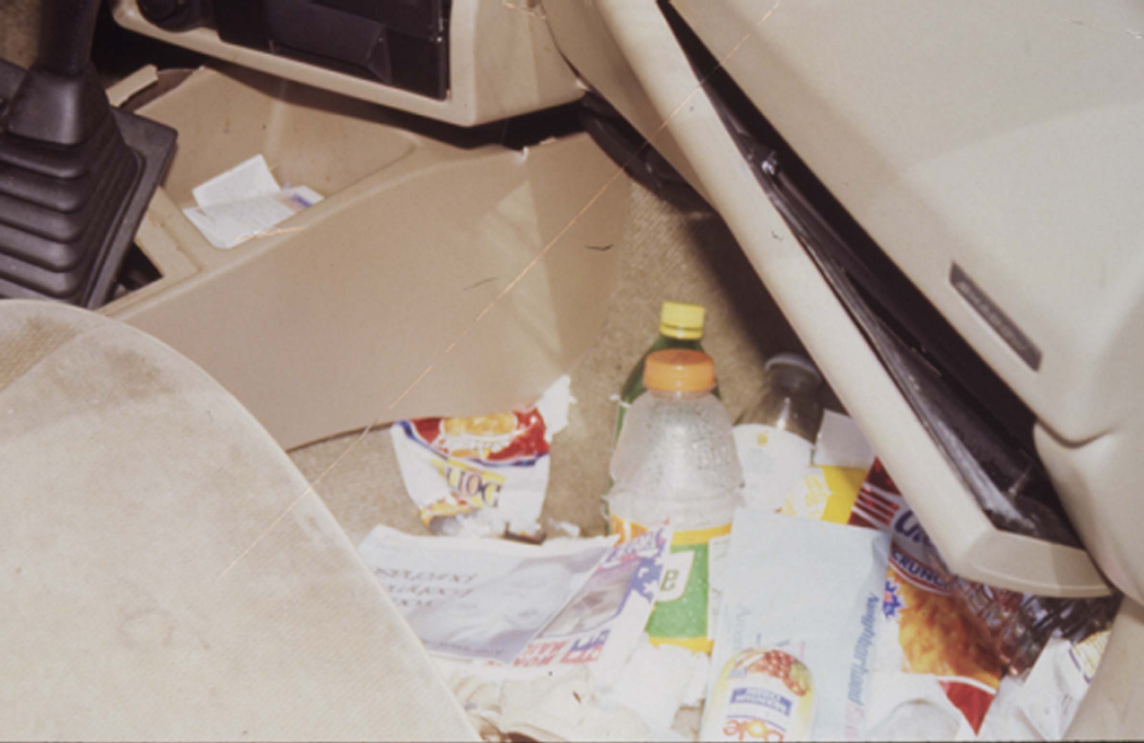
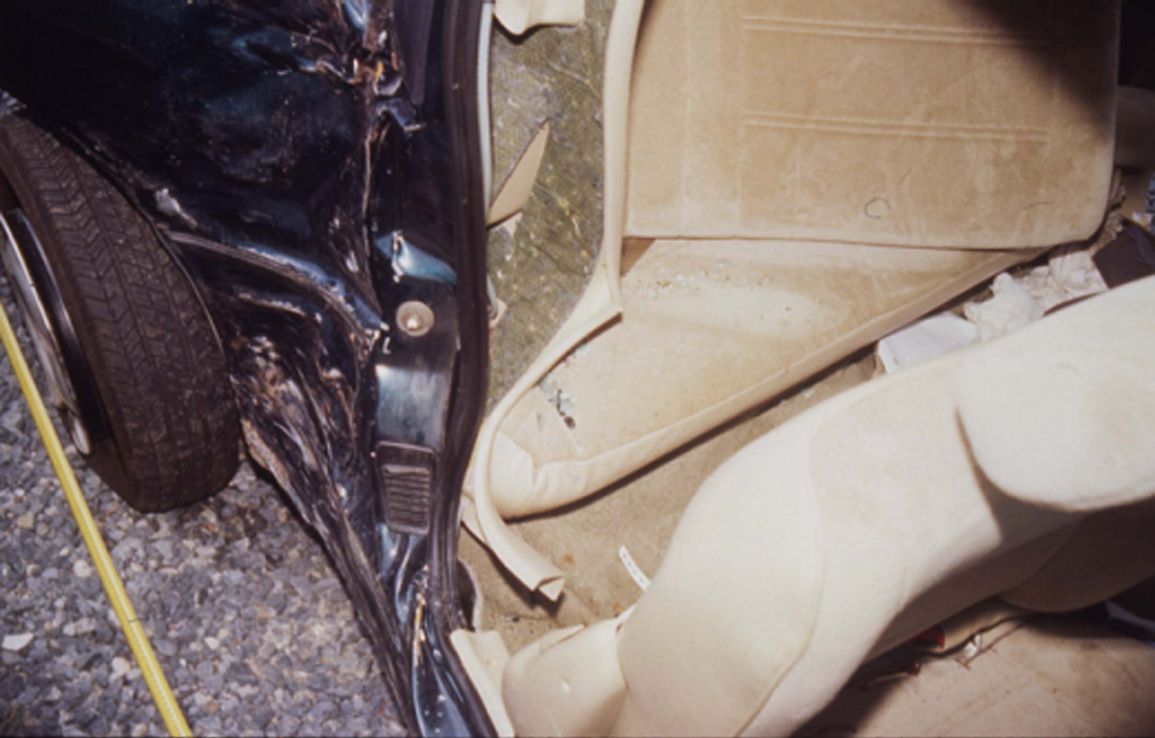
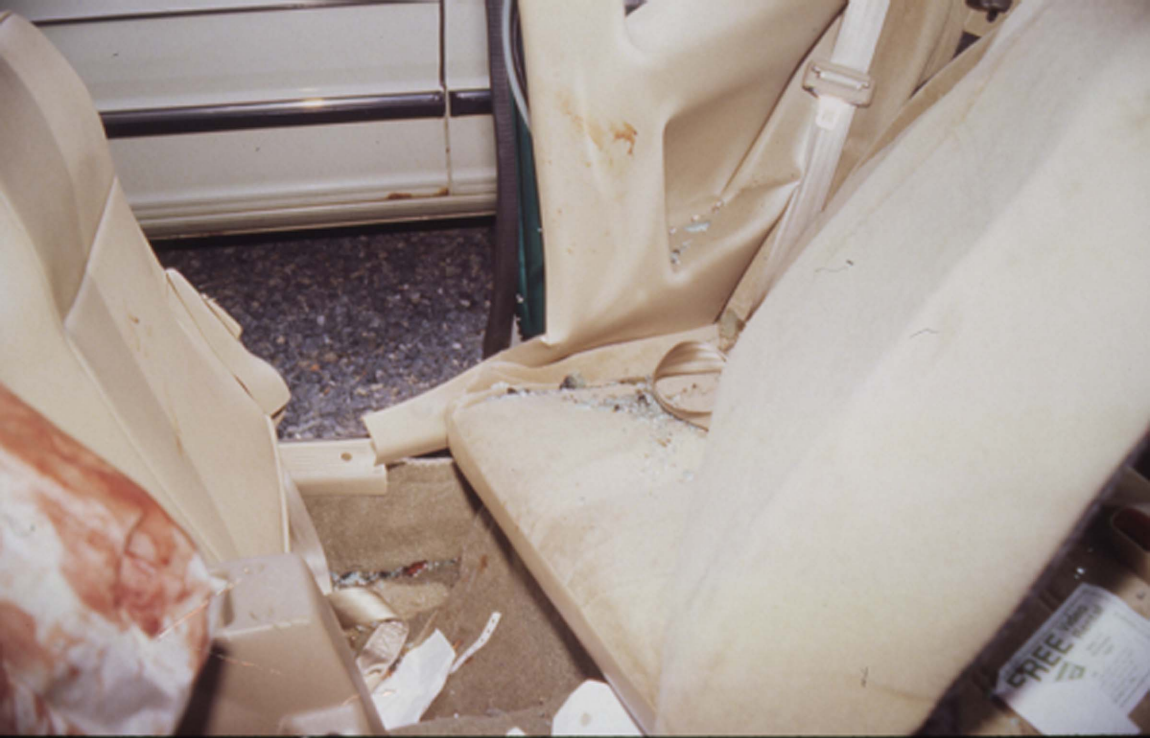
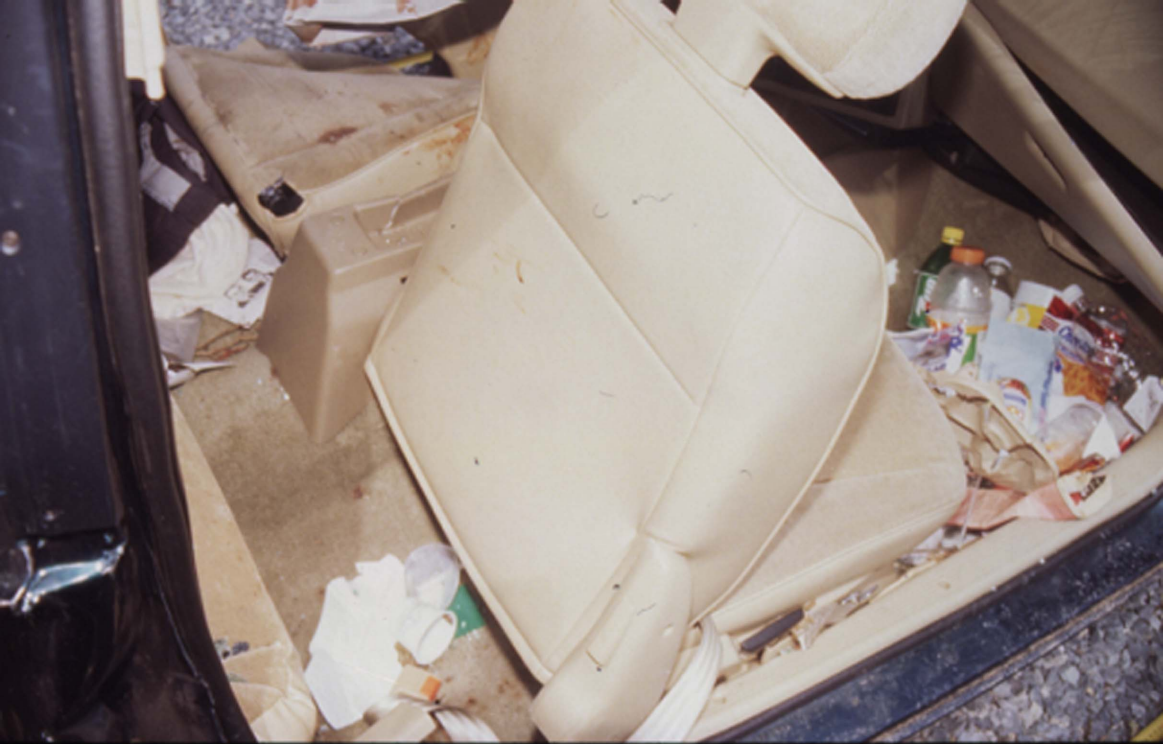
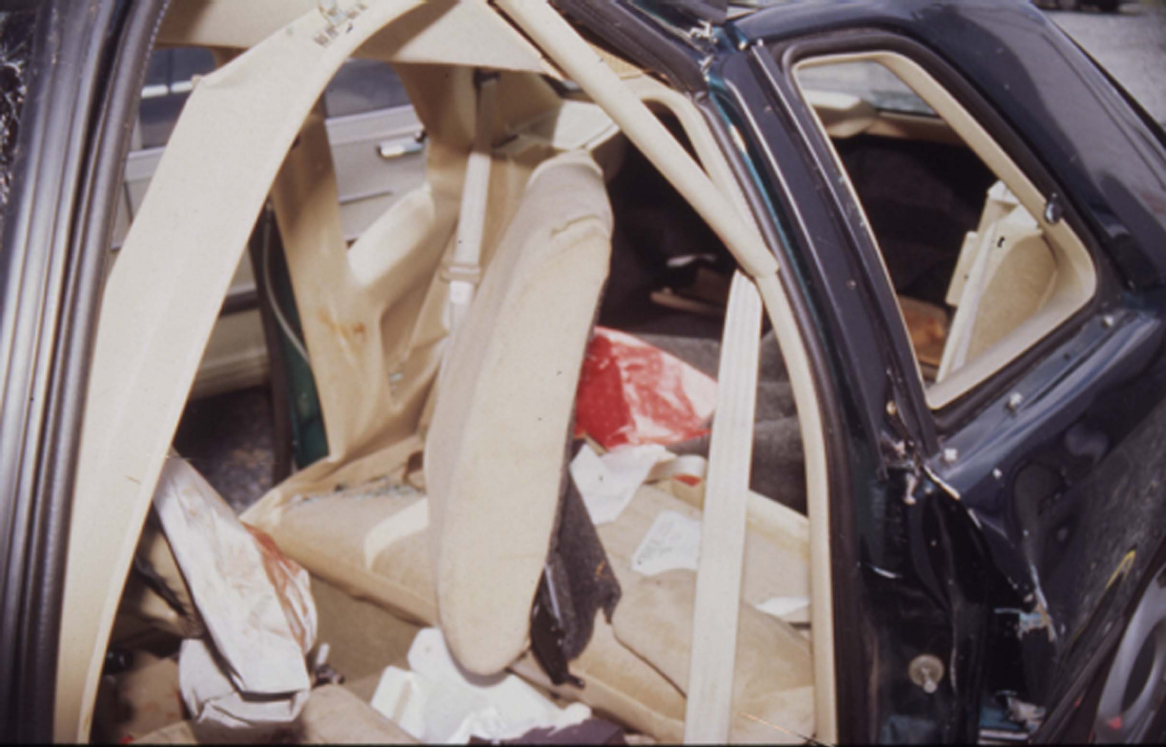
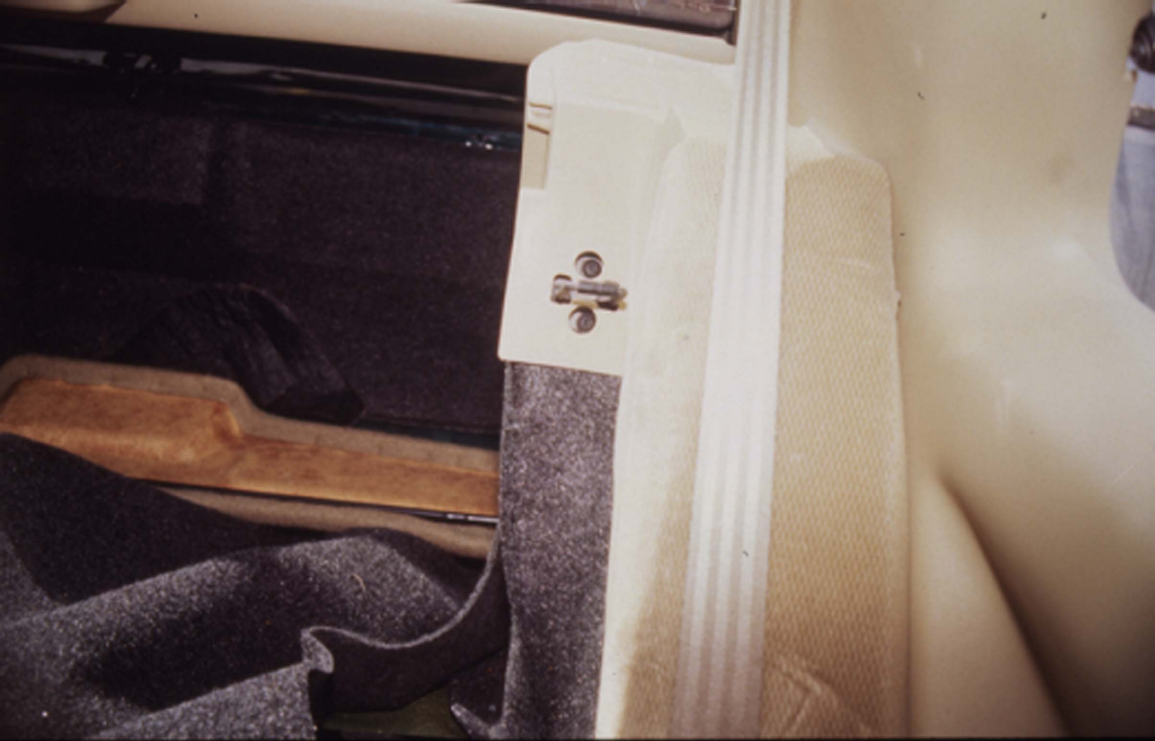
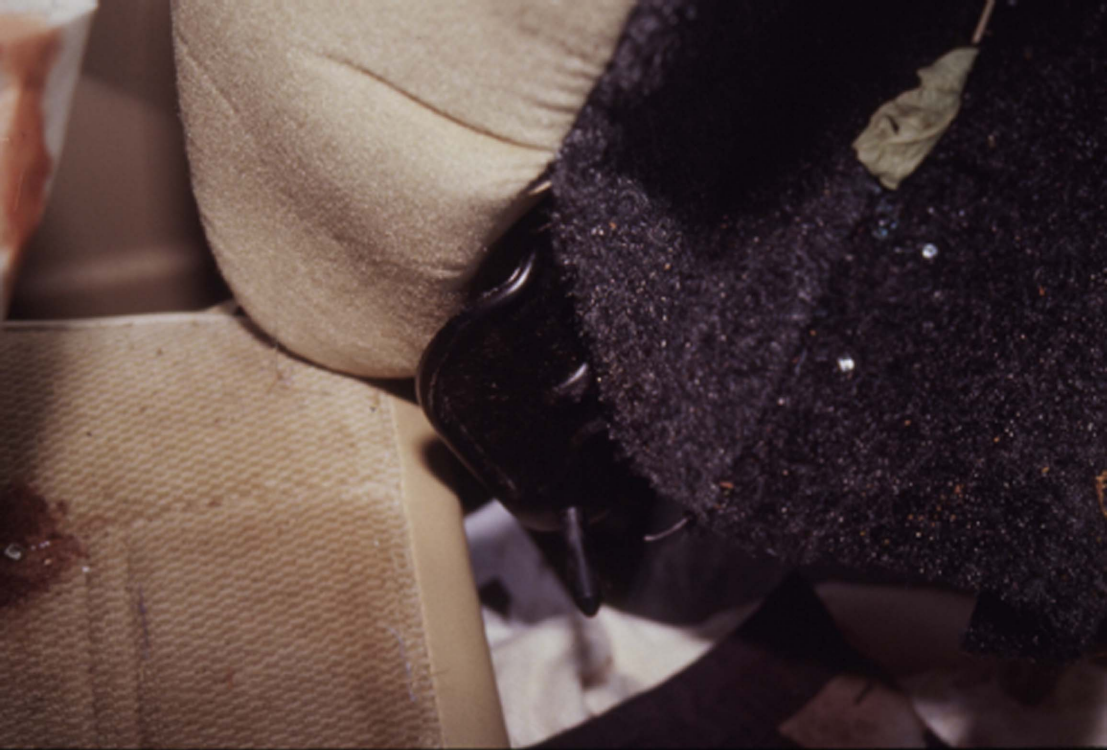
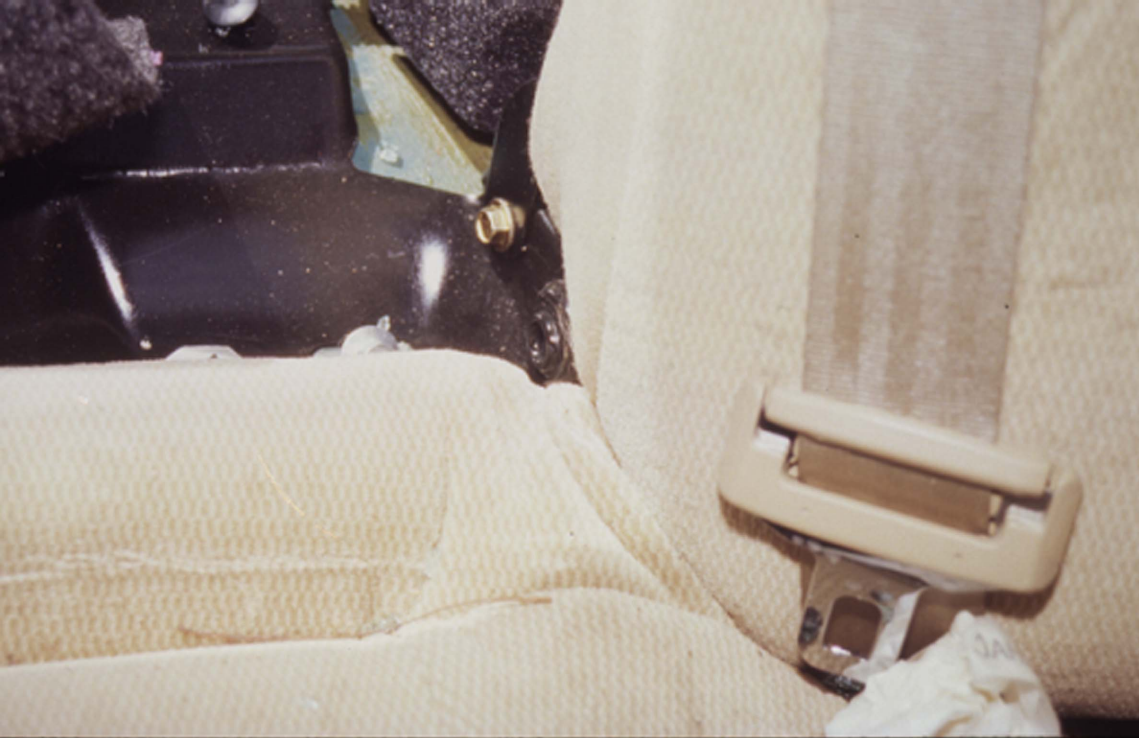
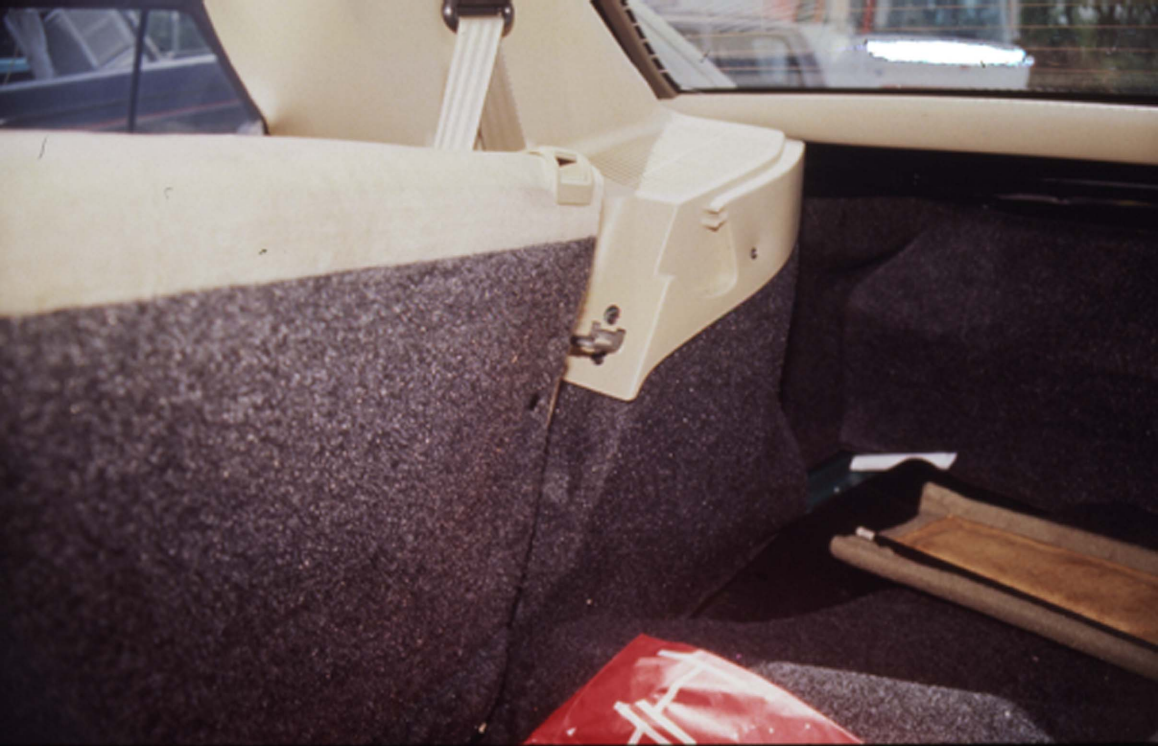
SLIDE NO.	VEHICLE NO.	ORIENTATION	SUBJECT MATTER
1	Vehicle 1	NW	Approach path, Vehicle 1
2-12	Vehicle 1	SE	Travel path, Vehicle 1 Slide 2 - R/F wheel departs roadway Slide 3 - L/F wheel departs roadway Slide 4 - R/F wheel crosses ditch Slide 5 - L/F wheel crosses ditch Slide 7 - POI 1, front plane with double guy wires Slide 11 & 12 - POI 4 & 5, L/F and R. side plane
13-14		SE	POI 6 and FRP
15-17	Vehicle 1	NW	Reverse travel path
18-30	Vehicle 1	CCW	Exterior views Slide 28 - Exterior, R/F door and L/F seat back rest damage from rear seat fold down back rest
31-52	Vehicle 1	---	Interior views Slides 40 - L/F door panel and front bumper beam Slide 45 & 46 - R/R intrusion Slide 49 & 51 - L/R seat back rest latch and fold down pivot Slide 52 - R/R seat back rest latch
